WATER QUALITY MASTER PLAN

THE VILLAGE OF ARDEN, DELAWARE

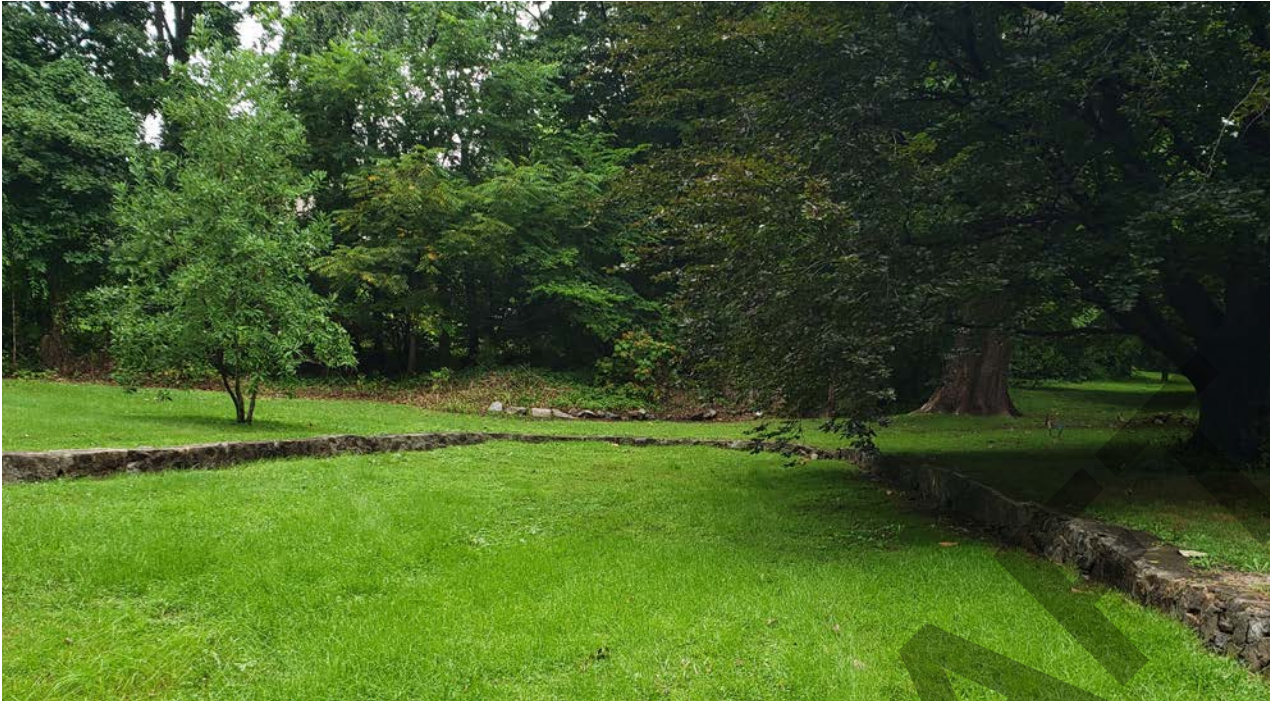
Memorial Garden looking northeast.

The existing open area at the base of the stone wall provides a large area to treat run-off prior to it joining the rock lined channel that leads to an eroded outfall at Perkins Run. BMP 8 proposes to transition this area to a bio-retention garden.

BMP 8 - This BMP utilizes the open space in the Memorial Garden. Currently there is an oval shaped depressed area with a stone curb around it. Pipe holes in the ground were observed in the area that suggest the area may have a drainage system within the footprint. The watershed for this BMP largely consists of the impervious area of Gild Hall, its surrounding pathways, a portion of its parking lot, the pool, and pool decking. An intervention in this area could treat some or most of the area highlighted in blue above BMP 8, an impervious area of approximately 1.28 acres, reducing overall effective impervious cover to 20.8%

BMP 8 - This facility is being proposed on common land within the Memorial Garden. This plan suggests implementing a bio-retention garden in the oval area enclosed by a stone wall. The footprint is suggested to stay as is and the depth increased, also, modifications to the area would be required to prevent run-off from bypassing the facility. The existing area has visible pipes and outlets that would need to be modified for a facility to function as intended. If further investigations of BMP 9 don't provide enough storage to improve the drainage along Harvey Road, this location may be able to capture some of the water coming into the upper catch basin. This is not being suggested in this plan as it entails similar constraints as BMP 9 and may be too intrusive for the Memorial Garden landscape; this suggestion is only provided as an option for further evaluation. The drainage area for the garden is ~210,900 sf. The impervious area within this watershed is ~55,800 (26.5%). A garden footprint as shown at 2ft deep would support a storage volume of ~5,100 cu. ft. This size would capture the water quality event of 2". Estimated costs for the facility would be \$271,115*.

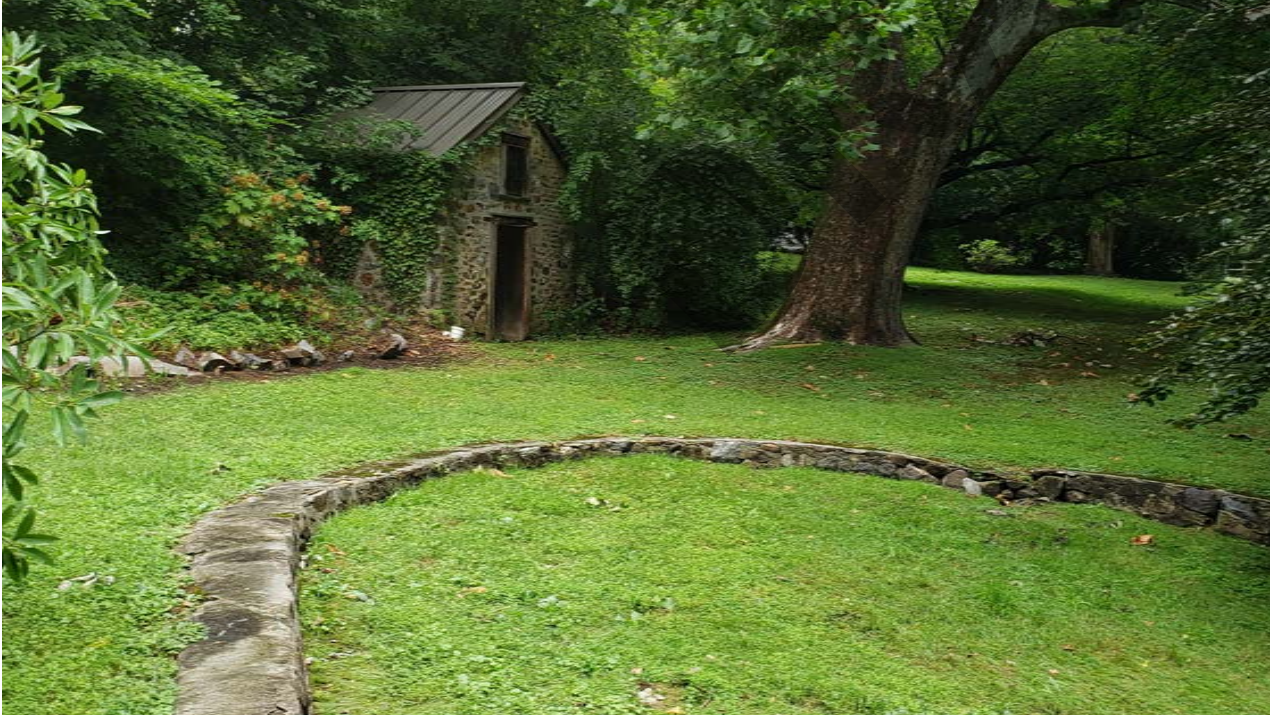
10

Memorial Garden looking northeast.

During a site visit running water could be heard in a PVC pipe opening at the edge of the wall along the north edge as shown in this image. The spring house may be hydraulically connected to the open area and further investigations needed prior to the design of BMP 8.

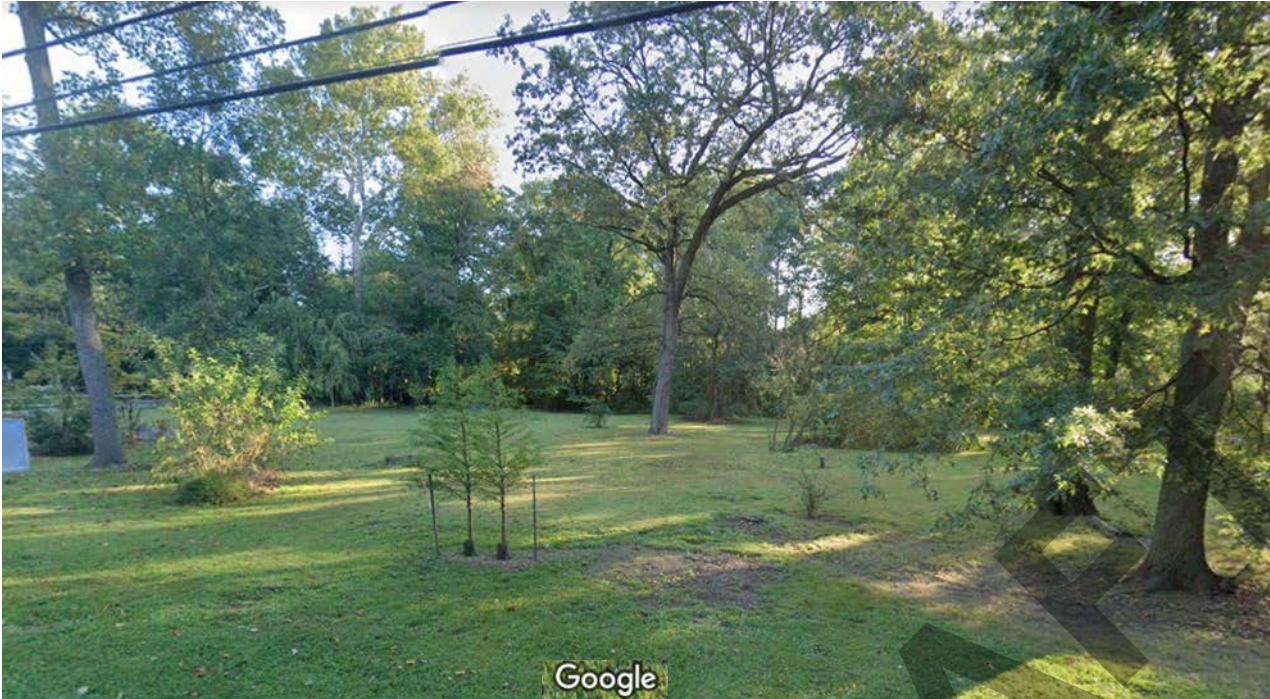
11

Harvey Road looking north into east extension of Memorial Garden.

BMP 9 - Harvey Road is the main north-south corridor that leads through Arden. The watershed for the length of Harvey Road within Arden appears to be limited to Arden lands. This conclusion is based on the topographic highpoint at the intersection of Marsh and Harvey Road, the crowned topography of Marsh Road, the catch basin network along Marsh Road that enters Perkins Run to the west, and the low point along Marsh Road to the east that directs run-off to Naamans Creek prior to it entering Arden lands. As a through-street, Harvey Road is the only non-Arden maintained road within its limits. It is also wider and has the longest continuous flow path over an impervious surface. It is suggested a further study be done in conjunction with DelDOT to determine opportunities to increase the drainage infrastructure along this roadway and increase water quality opportunities beyond the “bottom of the watershed”. It is our understanding there may be some hesitancy on the part of Arden to engage in conversations with DelDOT, as improvements may lead

BMP 9 - This plan suggests further exploration to the viability of a facility in this area. It appears the most viable area on common lands to provide water quality treatment and reduce drainage burdens along Harvey Road at the bottom of the watershed. However, visible boulders suggest excavation for a facility may be cost prohibitive due to the presence of bedrock or could require any facility to be shallow, thus taking up a larger footprint of the garden. Estimated costs unknown.

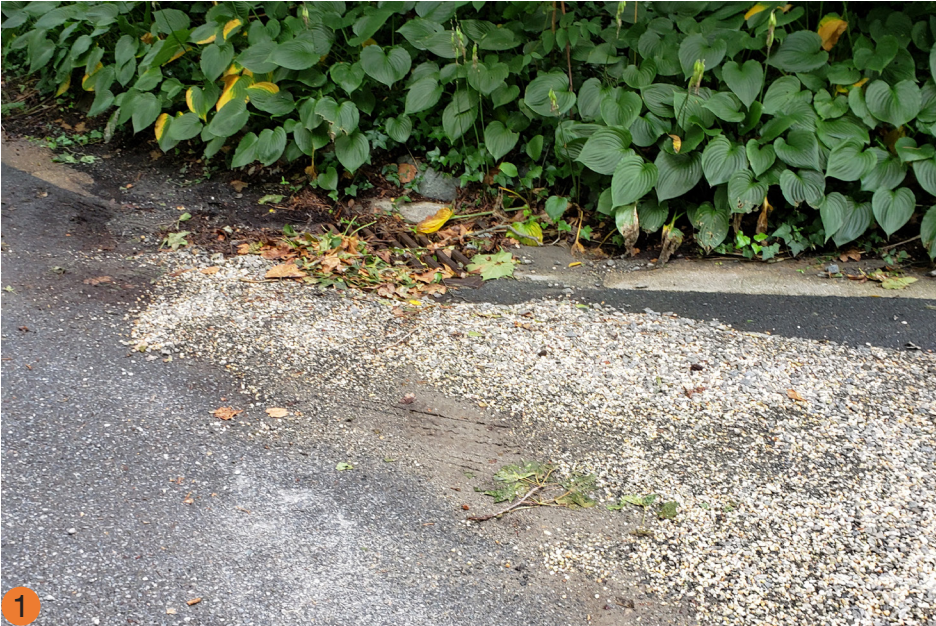
1

Intersection of Millers Road and Hillside Road; deposited stone visible around catch basins, likely washout from upstream stone driveways.

The last suggested intervention is to reduce sediment transport along Hillside Road and thereby reducing pollutant transport directly into the storm drain system at the bottom of the watershed. During a site visit stone from a driveway further up in the watershed was visible at the catch basin. If leaseholders with stone or compacted soil driveways implemented porous paving for their driveways, or at a minimum, the apron area at the intersection of the road and the driveway, this will help reduce sediment transport and aid in improving water quality. Given the lack of space in Arden maintained areas along Hillside Road, any leaseholder initiatives, such as rain gardens or cisterns would also be beneficial to the watershed.

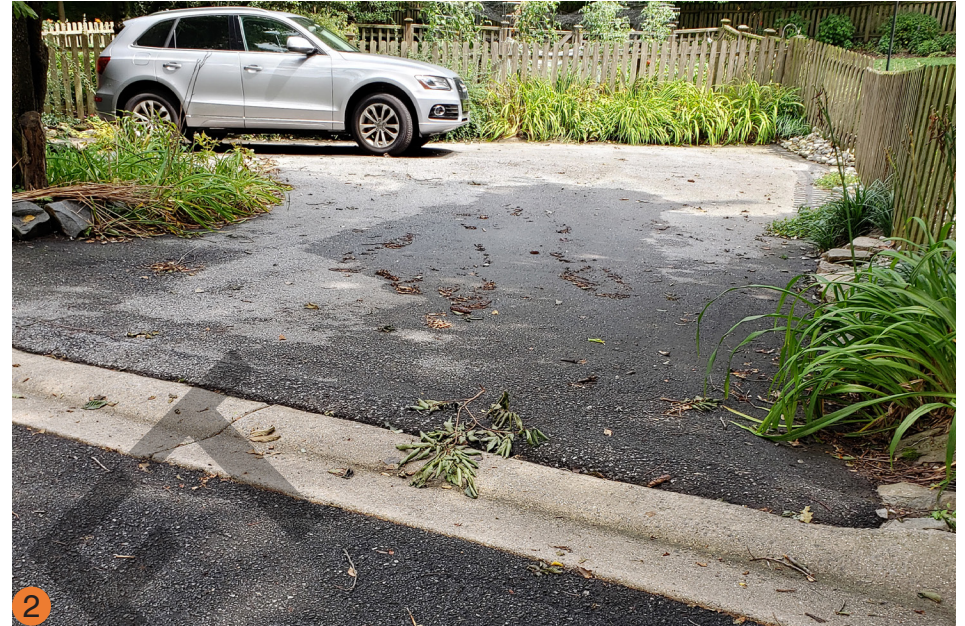
2

Leaseholder driveway; wet driveway markings and visible erosion suggest unmanaged storm runoff in this leasehold and the downslope leaseholder.

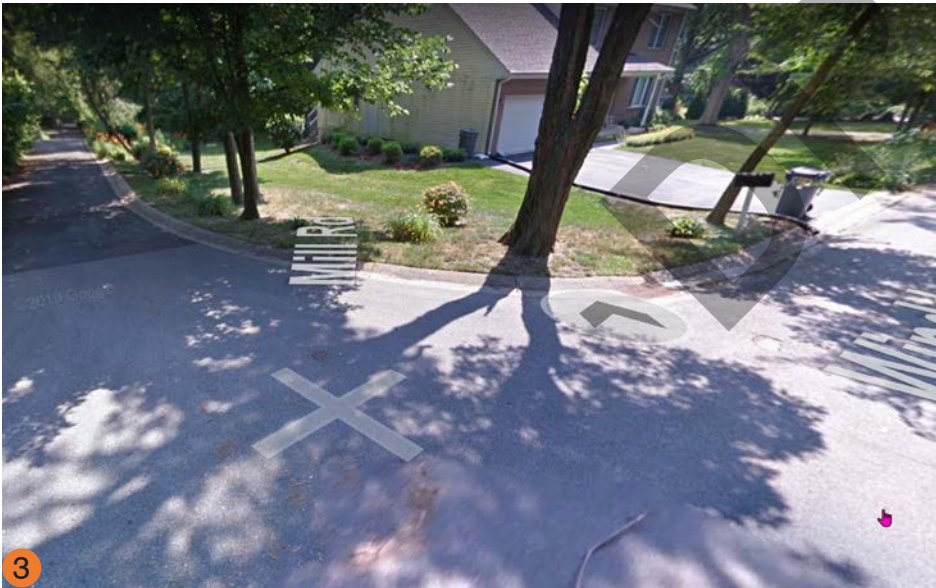
3

Intersection of Mill Road and Wind Lane; debris in valley gutter suggest mild low point; also visible in the background of this image is the steep gradient down Mill Road from this intersection.

The second recommended BMP is bio-retention garden E2 at the southwest corner of Wind Lane and Mill Road/Mill Lane. This corner is where stormwater appears to combine and gain momentum downhill along Mill Road. Reducing the intersection radii and implementing a BMP at this location would benefit drainage by slowing the stormwater flows higher up in the watershed and allow time for pollutants to settle out. An intervention in this area could treat portions of the area highlighted in deep blue, with an impervious area of approximately

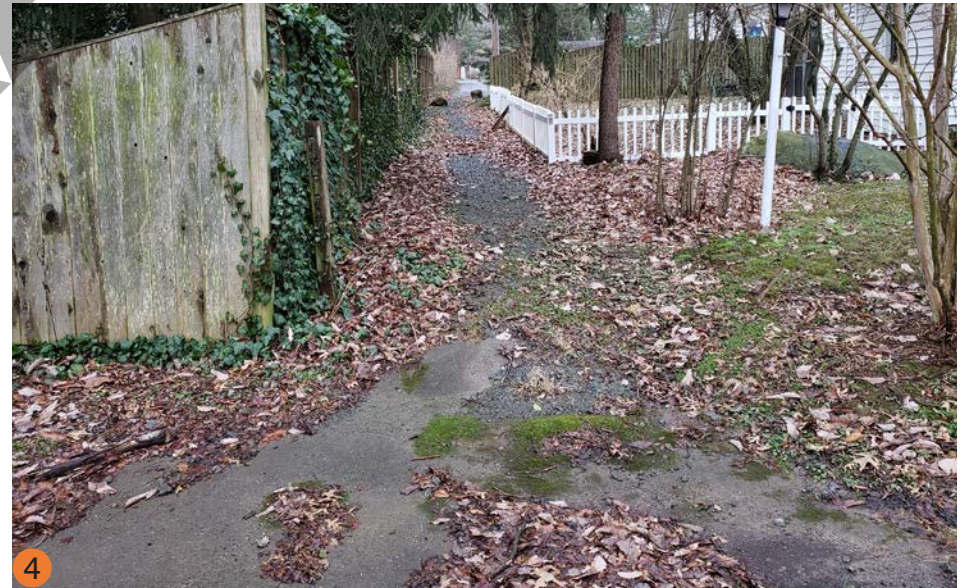
4

Mill Lane; image taken from Wind Lane intersection with Mill Lane in the far background; note the debris lines from stormwater runoff flowing through the area.

To assist in treating water quality and preventing sediment and pollutant transport downstream, it is suggested an area of porous paving be installed and two bio-retention gardens. With Mill Lane appearing to be a dead end vehicular street with only pedestrian movement through to Mill Road, transitioning it to porous paving appears to have minimal feasibility constraints. Utility conflicts and under-drain connections would need to be professionally designed. The area illustrated to be replaced with porous paving, E1, is approximately 3,000 sf. and includes both the paved surface and stone surface connection to Wind Lane. The drainage area for the porous paving is ~40,770 sf. The impervious area within this drainage area is ~8,700 sf. (21.4%). The footprint as described at 1ft deep would support a storage volume of ~1,200 cu. ft. This size would capture the water quality event of 2". Estimated costs for the facility would be \$73,800*.

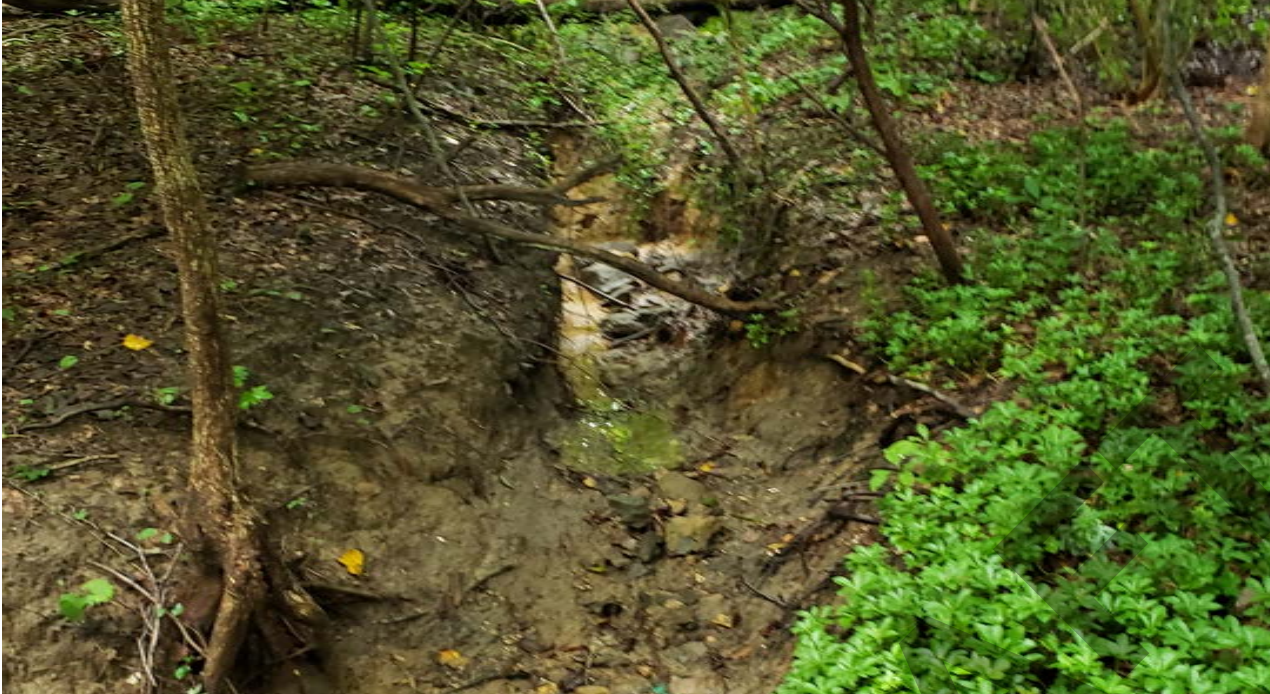
1

Channel in woods opposite Little Lane, view downstream.

The eroded channel through the woods varies from 1' to 3' deep and is actively eroding carrying sediment to Naaman's creek and undermining woody vegetation to either side of it.

To assist in treating water quality and preventing sediment and pollutant transport downstream, it is suggested a BMP be designed for the outfall and/or the eroded woodland channel, by way of stream/channel restoration. Whatever BMP/restoration initiatives are taken, it is likely some amount of woodland clearing will be required, and likely on leaseholder land. This should be discussed by Arden and the leaseholder(s) prior to any design and implementation as leaseholder input could be a deciding factor in the best method of repair.

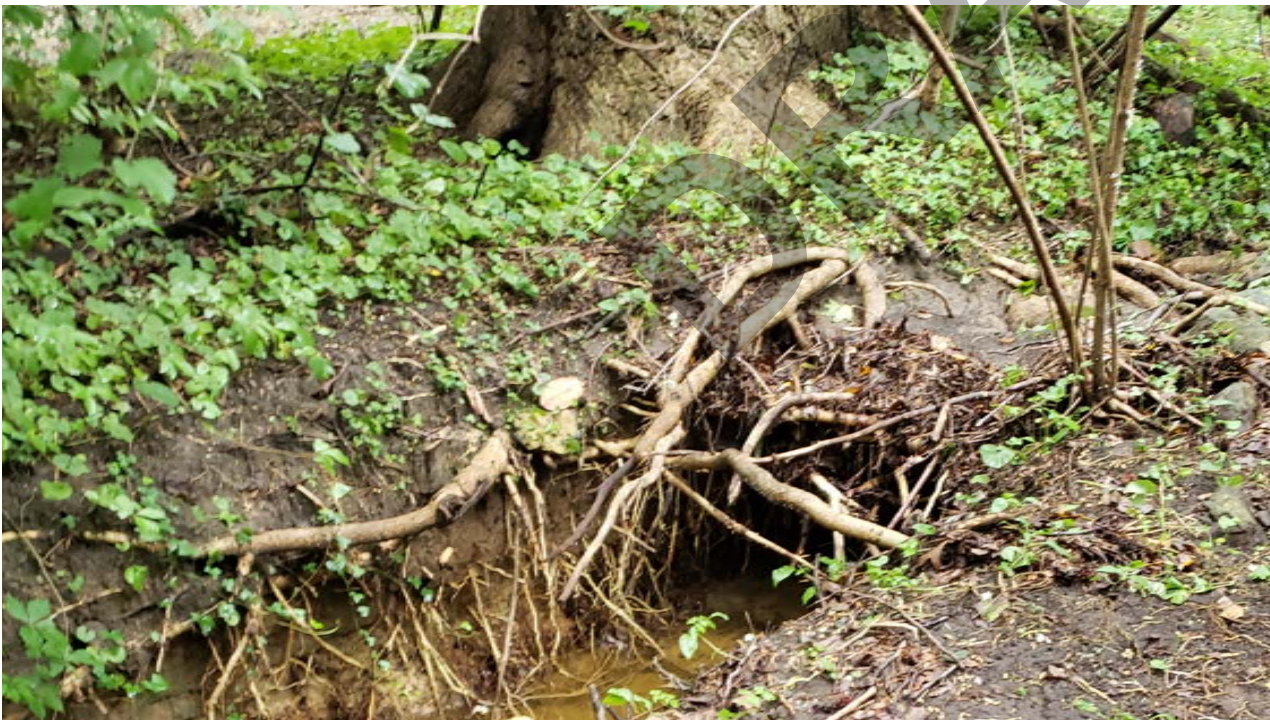
2

Channel in woods opposite Little Lane, view upstream .

At the top of the channel there are several large mature trees. For the time being this one is helping to slow the water by impeding its velocity downstream with its strong roots. Given the forecast of increasing storm events, this channel will likely continue to erode. Restoration measures can aid in preventing this tree's roots from becoming undercut which can have a negative impact on tree health and potentially destabilize the tree.

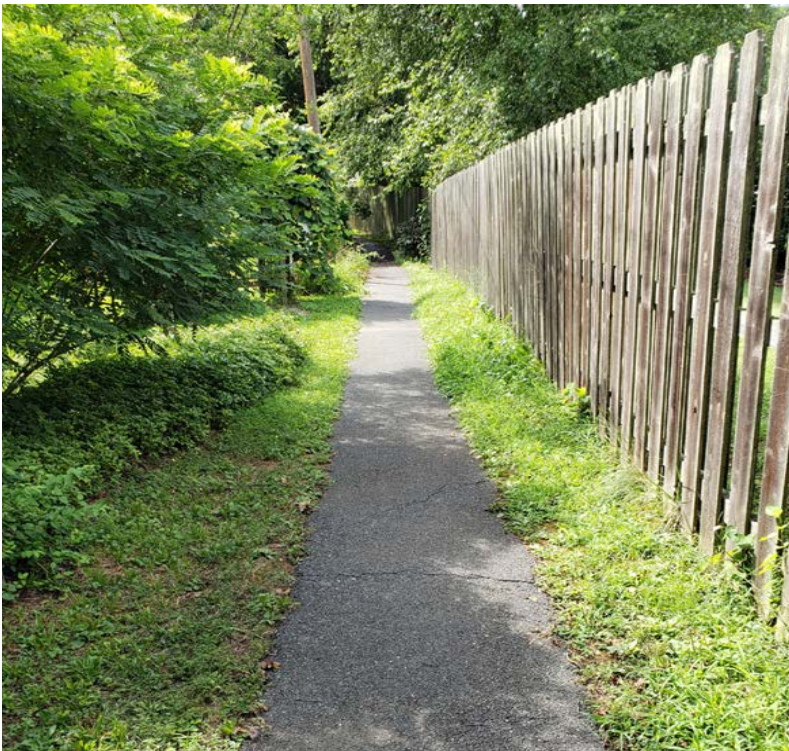
1 The Grocery Path looking north toward Little Lane.

The path is extra impervious in the watershed that overtime could be changed to a material that supports water quality improvements within the Arden. Regardless of material changes, the availability of Arden maintained land will aid in creating conveyance connections from the proposed rain garden BMPs to the downstream drainage network during overflow events.

The transition of the existing asphalt Path to porous pavers or porous asphalt should be evaluated in regard to maintenance requirements Arden thinks would be feasible for them to undertake. The path is narrow with a limited footprint within common lands and access for equipment could be tight and should be considered in the evaluation. The area illustrated for G1, to be replaced with porous paving, is approximately 3,200 sf. The drainage area for the porous paving is ~19,300 sf. The impervious area within drainage area is ~6,350 sf. (32.9%). The footprint as described at 1ft deep would support a storage volume of ~1,250 cu. ft. This size would capture the water quality event of 2". Estimated costs for the facility would be \$76,900*.

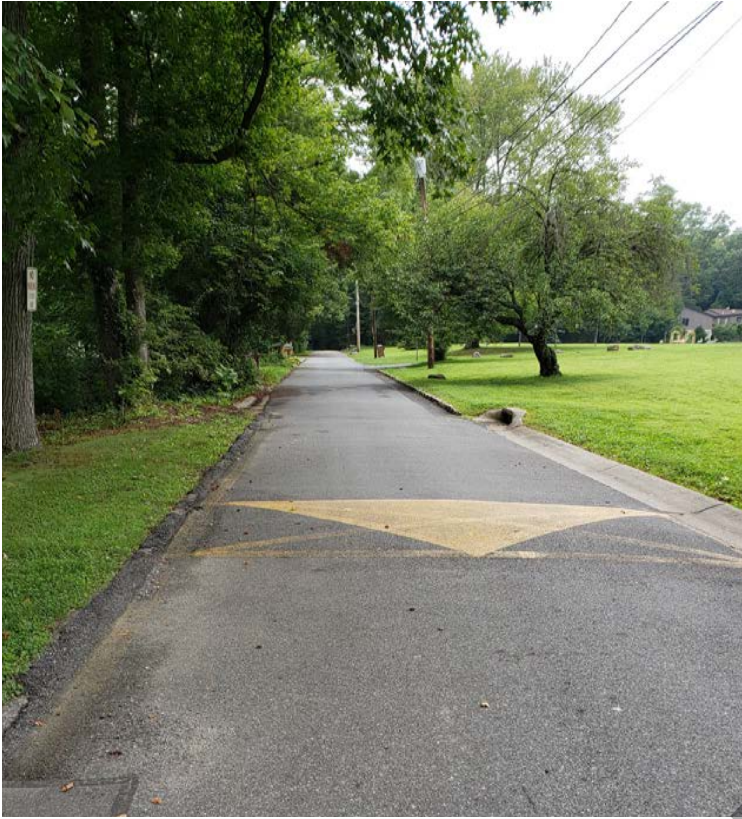
1

Woodland Lane looking east.

The storm drain network on the south side of the road and the elevated curb in several locations along the north side direct untreated stormwater runoff to Naamans Creek. Opportunities to disconnect the flow paths and integrate water quality initiatives will help mitigate vehicular generated pollutant loading in the Creek.

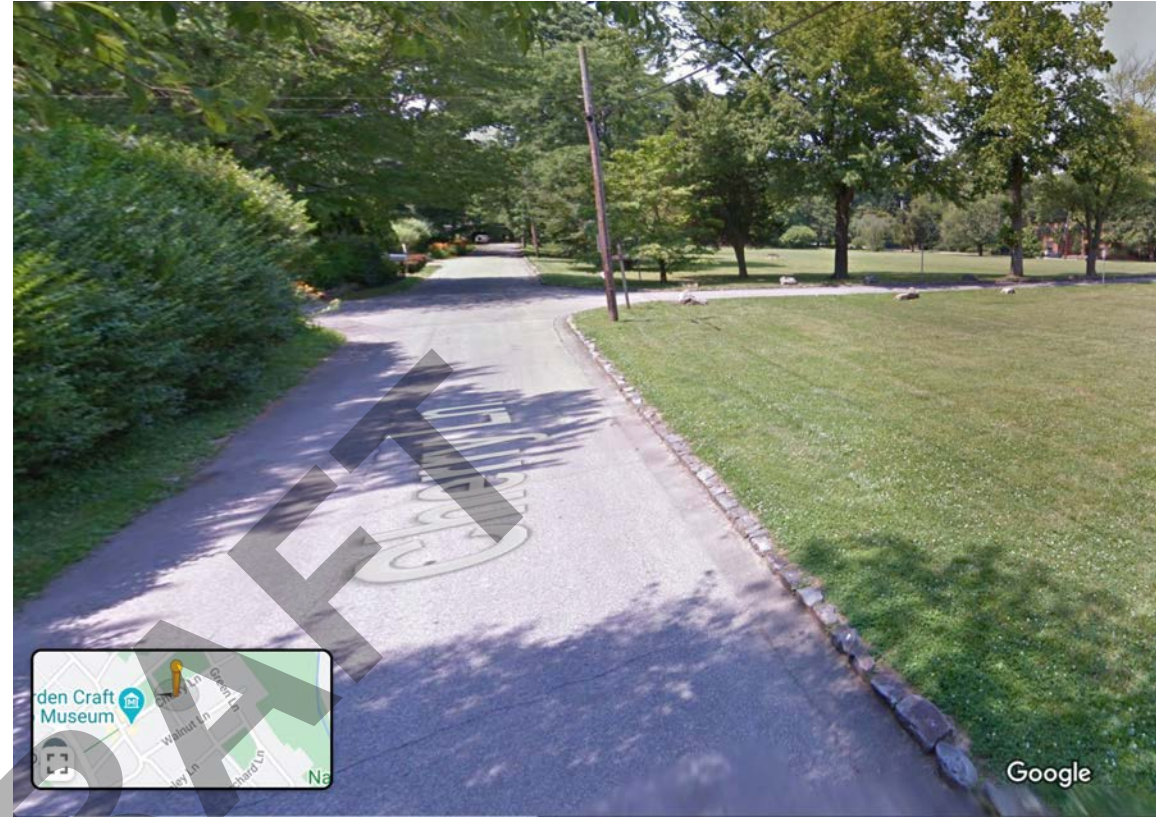
2

Cherry Lane looking west.

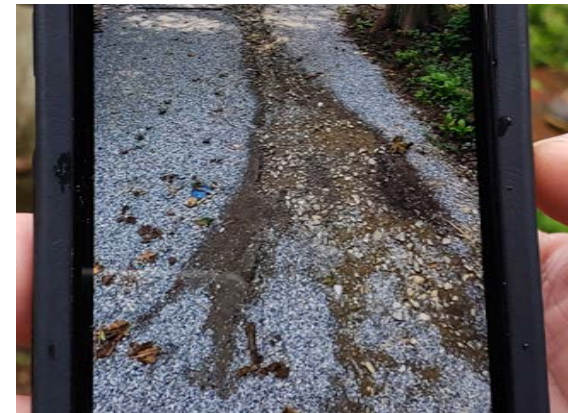
3

Leaseholder image looking at driveway erosion along Woodland Lane.

Drainage initiatives help reduce erosion higher in the watershed however, water quality BMPs for the runoff, before or after drainage infrastructure, should be implemented where feasible.

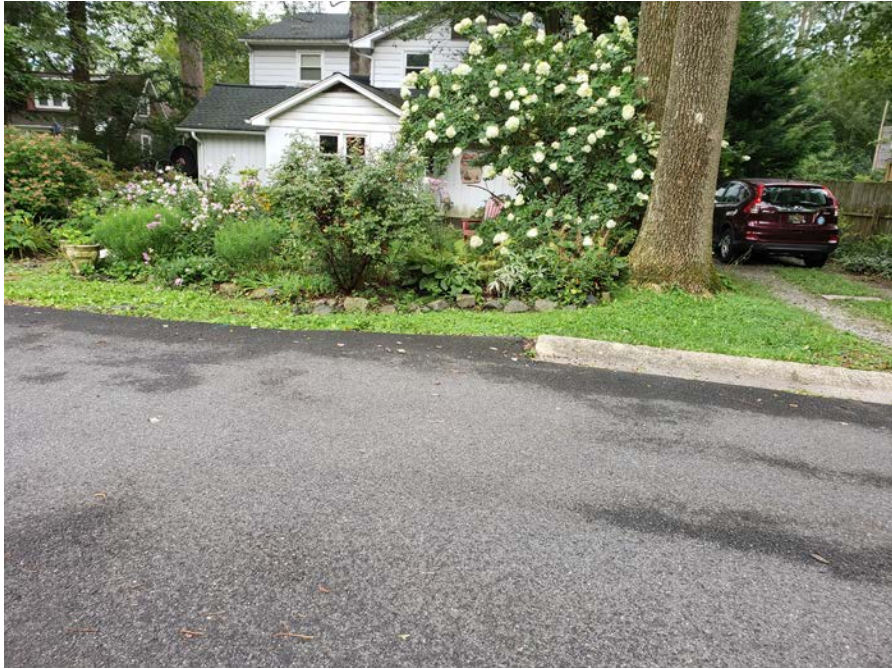
1
Image looking south
where valley gutter ends
and planter could be
implemented.

Two opportunities for water quality improvements were observed within the watershed and illustrated with a purple dot. Inn Lane is crowned and the western half is caught by gutters along Walnut Lane and directed to Watershed J; the eastern half does not appear to change direction at Walnut Lane and continues south into leaseholder lands. To treat the Inn Lane road runoff in this watershed, stormwater planter I1 could be implemented in the narrow lawn area in front of 2314 Walnut Lane. The planter would need to have a toothed upright curb to allow stormwater in but prevent vehicles from driving off the road. A review of the downstream drainage connections in Ardentown is recommended prior to undertaking design to fully vet the feasibility and potential cost of this BMP. Before implementing the BMP, a safe overflow path should be identified so no downstream residence in Ardentown is negatively impacted. Planter I1 in this area could treat all or most of the drainage area illustrated in light blue with an impervious area of approximately 0.24 acres, reducing overall effective impervious cover to 10.9%. The drainage area for the planter is ~25,700 sf. The impervious area within this drainage area is ~10,300 sf. (40%). A planter footprint as illustrated at 1.5 ft deep would support a storage volume of ~1,050 cu. ft. This size would capture the water quality event of 2". Estimated costs for the facility would be \$55,900*.

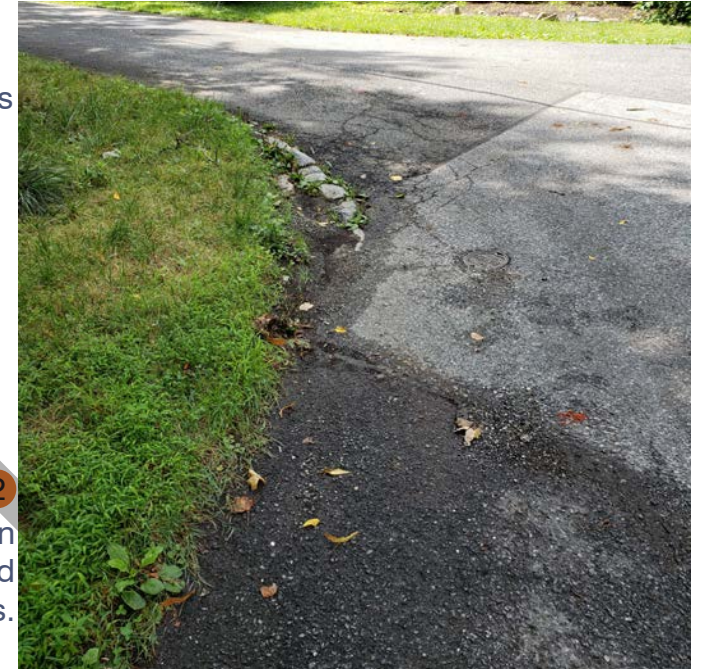
The second opportunity illustrated in this watershed, I2, could also be implemented in several areas throughout Arden. During site visits vehicle tracks indicated vehicles cutting corners and ruts with tracked sediment observed on roadways. This is a common water quality impairment in many areas and is just one of the many pollutants present on roadways that are transported to our streams via stormwater runoff. Installing any hardscape material to form an apron behind the curb and/or edge of pavement would reduce the sediment dispersal, this plan recommends using a porous material to still allow for potential infiltration. Porous asphalt is generally more cost effective than porous paving, particularly for large areas such roadways. The small footprint of these intersection reinforcement areas may benefit from an interlocking paver producing more stability overtime with tire wear and having a dissimilar material marking the roadway versus the apron area. An intersection as illustrated, reinforced at all four corners is estimated to be \$10,600 at approximately \$17.75 per square foot.

2
Image of intersection
with vehicle generated
tire ruts.

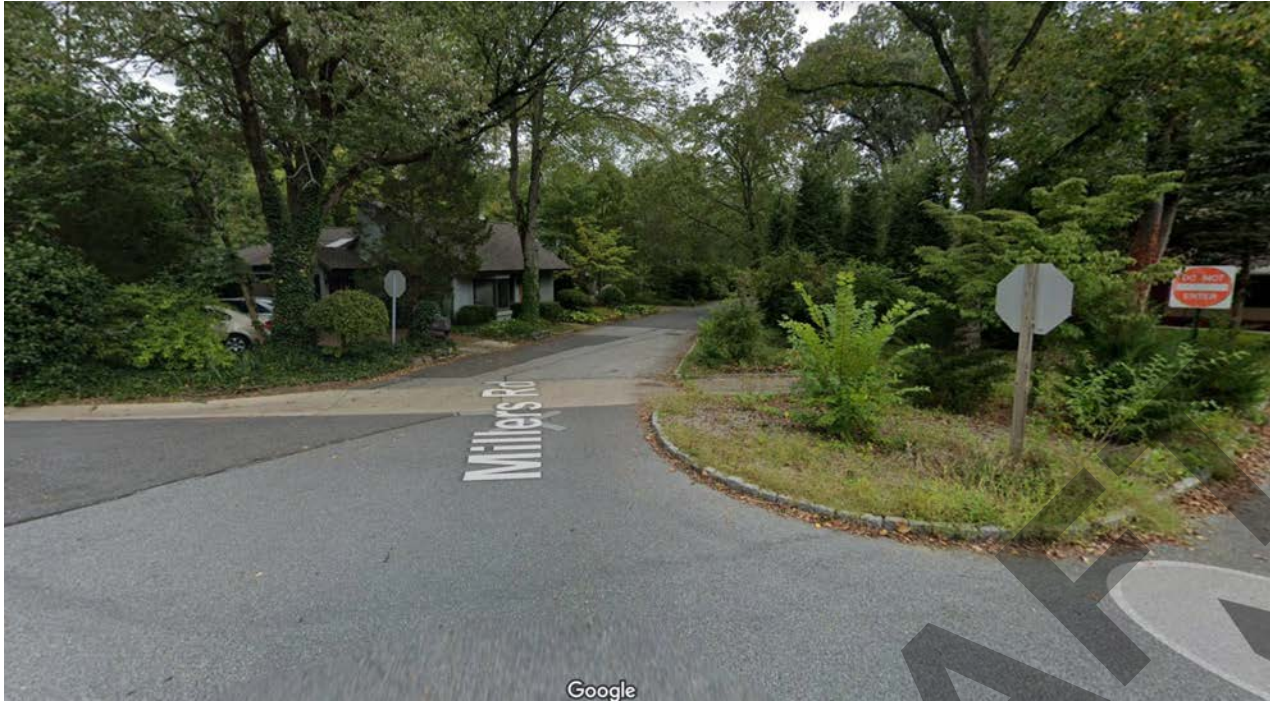
1

Millers Road Walnut Lane intersection looking south

The existing concrete valley gutter drains water to the catch basin system along Lower Lane by traversing through the landscape island.

An option within this watershed that was not detailed further is the potential to install an underground storage system in the area of the parking bump out at the intersection of Millers Road and Walnut Lane, such that a catch basin might be installed at the end of the valley gutter coming from the north side of Walnut Lane. Underground storage has minimal effect on water quality directly. As discussed in the introduction, managing drainage can lead to indirect water quality benefits. This is particularly relevant in this location with the downstream watershed being the bottom of Harvey Road, as discussed in Watershed C. If further investigations make a BMP in area 9 of Watershed C impractical, this location may be beneficial in capturing larger storm events upstream to reduce the pressure on the downstream drainage network.

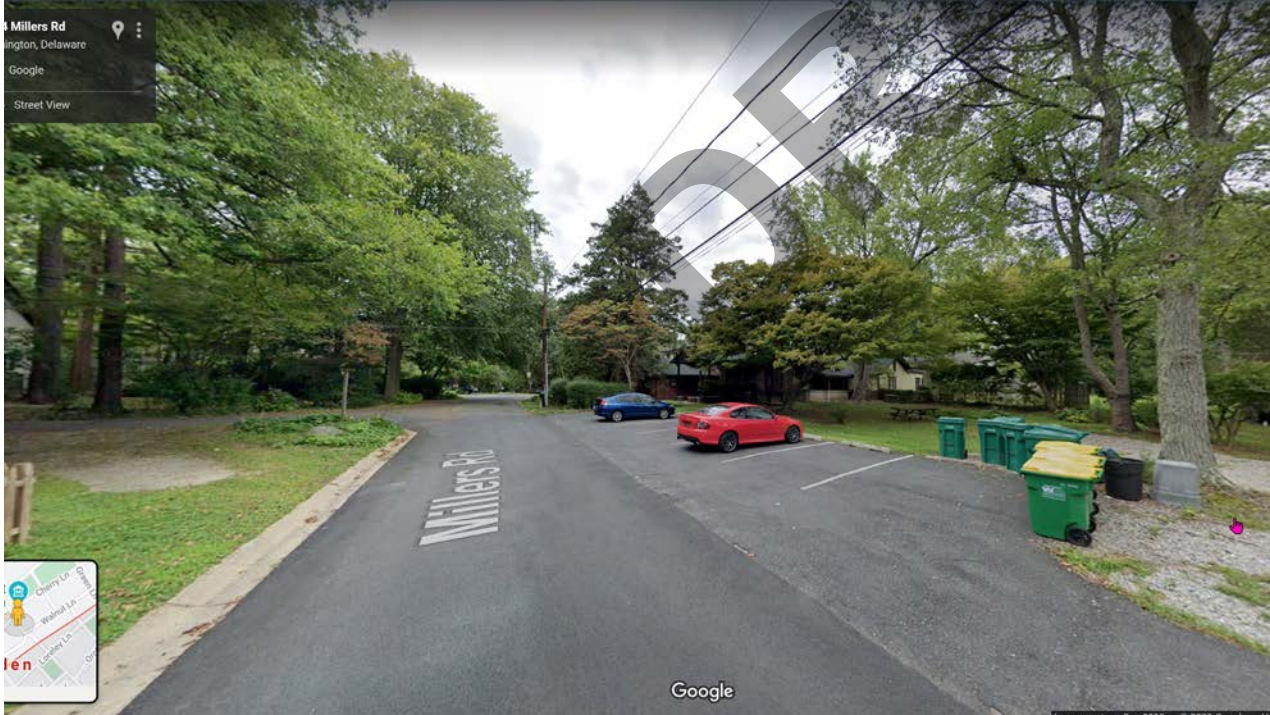
2

Craft Shop parking lot, image looking north.

Opportunities to transition public lots to porous materials will increase water quality treatment in Arden.
